The Negative Impact of Solar Reflections Caused by Reflective Buildings' Facades: Case Study of the Nasher Museum in Texas

Sahar Abdelwahab¹, Mariam Elhussainy¹, Rania Labib^{2,3}

Abstract. Large reflective facades in buildings can cause severe visual discomfort due to the reflection of sunlight falling on buildings' surfaces. These intense reflections can cause a intolerable glare and contribute to overheating the interior of surrounding buildings.

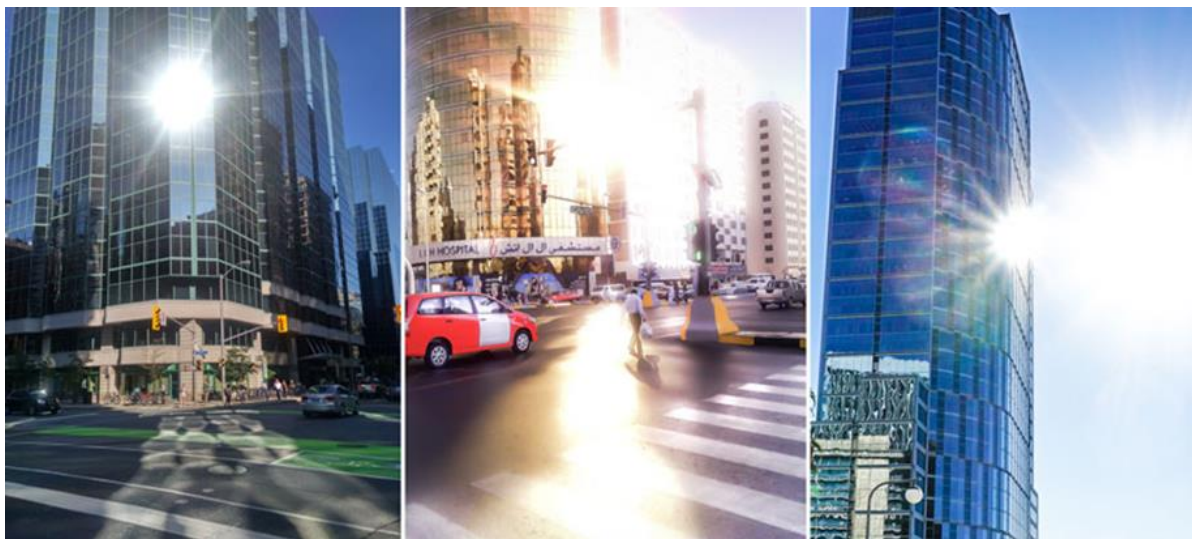
Figure 1. Examples of intense solar reflections in urban settings causing severe visual discomfort¹

Reflective façade is a popular architectural feature that is widely used in buildings, especially tall buildings in condensed urban settlements. In the last few decades, architects have been inspired by the contemporary architectural style, which utilizes full glazed building façades despite the noticeable differences in thermal requirements across diverse climatic regions. The increased preferences to use glazed façades in buildings contributes to severe visual discomfort due to the excessive sunlight internally received and, equally important, external reflection of sunlight falling on buildings' surfaces. The intense external sunlight reflections on buildings can cause an intolerable glare, which can impair the vision of surrounding buildings' occupants thus hindering them from performing their daily tasks. Figure 1 shows various examples of sunlight bounced off glazed façades causing blinding glare.

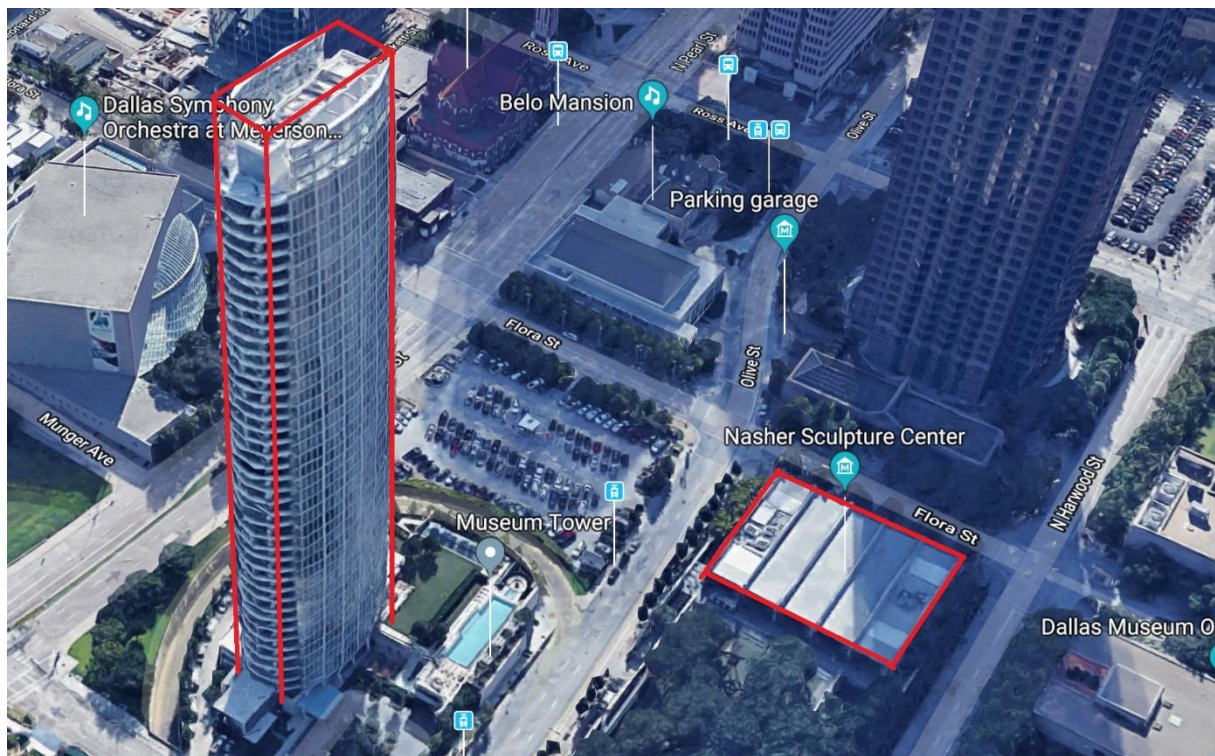
Figure 2. Nasher Sculpture museum and the Museum Tower highlighted in red. The tower's façade faces the south-west direction.

The ceiling of the museum is comprised of five glass vaults nestled between the seven travertine walls, which are extended above the pavilions. A shielding system, made up of aluminum panels, is positioned above the glass ceiling. These three-dimensional elements, whose design has been patented, are repeated 223,020 times and only allow for the passage of direct light from the north. The Nasher museum is across the street from the Museum Tower. The façade causing glare is facing the south-west direction. (see Figure 2)

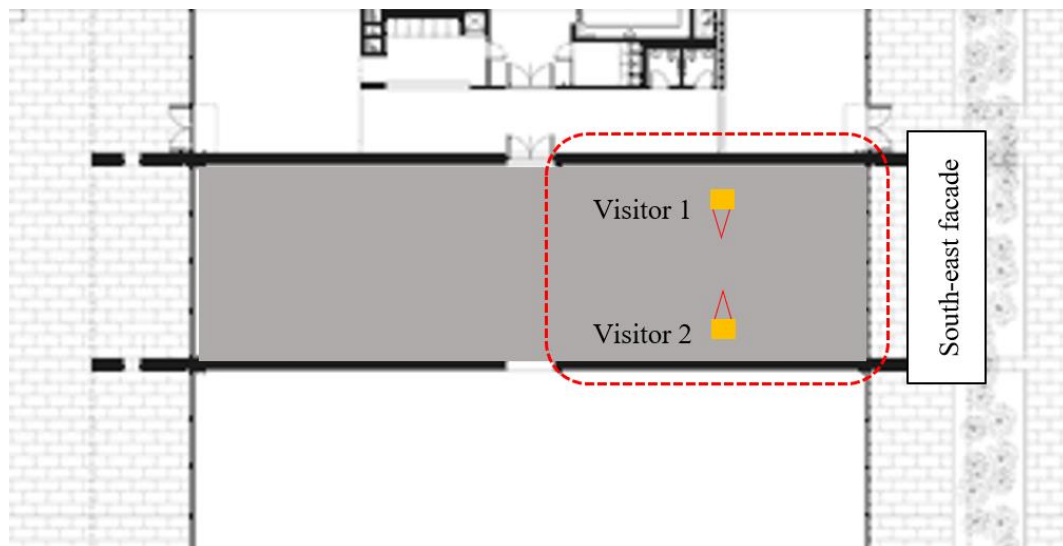
Figure 3. The simulated pavilion and visitor locations.

Daylight Glare Probability DGP [13] was used as an indicator for the received glare. The evaluation of DGP was based on the DGP rating proposed by Wienold [14]: imperceptible glare= $DGP \leq 0.35$; perceptible glare= $0.35 < DGP \leq 0.40$; disturbing glare= $0.40 < DGP \leq 0.45$; intolerable glare= $DGP > 0.45$. DGP was measured from a perspective of two subjects: visitor 1, and visitor 2 (shown in Figure 3) standing in front of a sculpture (0.6x0.6m cabinet) at a distance of 1.5m. The Museum Tower is in the field of view of visitor 1, while visitor 2 faces the opposite direction. (see Figure 3).

The two view positions were chosen close to the south-east façade, so the probability of severe glare occurrence from the ceiling and the facade can be clearly tackled (preliminary analysis showed that this particular façade receives excessive direct light compared to the north-west façade).

A model of the five-pavilion museum, in addition to the museum tower, was modeled. The pavilion, shown in Figure 3, was tested for glare performance as one of the three middle pavilions that house the sculpture and, more importantly, it is the closest pavilion to the museum tower where severe light reflection from tower's skin is more likely to occur. Figure 4 shows detailed Rhino scenes for the model built for the Museum and the museum tower.

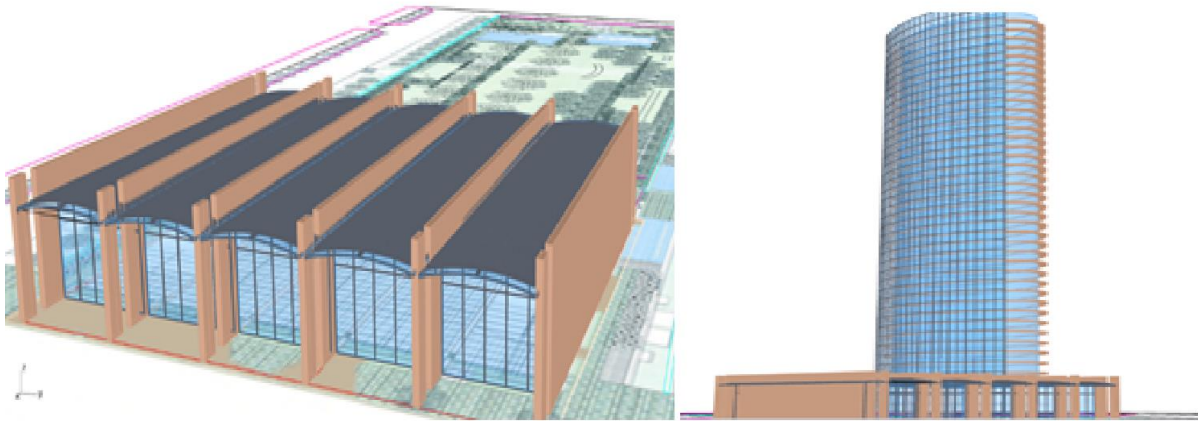
Figure 4. Rhino scene for the modeled Nasher Museum and the museum tower.

Material characteristics of the museum and the museum tower were mainly based on the described materials in the museum description section, solar control glazing with low-e coating was used for museum facades, while the interior walls finished with Italian travertine were assumed with a 70% reflectance. The ceiling was modeled with aluminum roof structure (so as façade mullions) and shielding system made of aluminum panels on top of clear glazing. Floor tiles were assumed with 40% reflectance. The external ground was modeled with 20% reflectance. The analysis considered no external abstractions except for the museum tower.

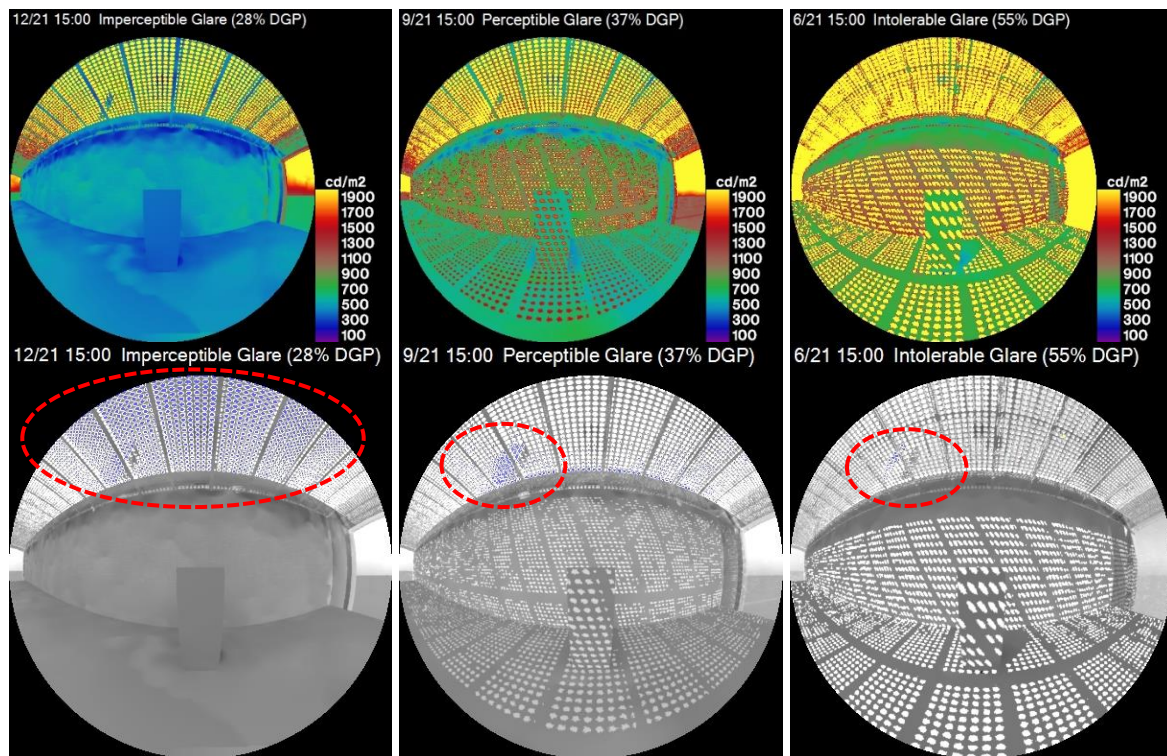
Figure 5 Example for luminance maps generated from the perspective of visitor 1 (facing tower's direction) on the top, and the potential sources of glare detected (blue patches) on the bottom.

The examples of luminance maps in Figure 5 show that the museum tower does not provide any shading for the museum's roof. Rather, high reflective envelope reflects excessive sunlight, except for some parts in the tower's south-east-elevation, where low luminance levels from the non-reflective slabs were detected. However, it should be noted that, in general, both light sources (i.e. sun, sky) and the reflected light from the tower may contribute in receiving high DGP at 12 pm because, as expected, the sun has a high angle and therefore sunlight is excessively received through the glazed roof. On the other hand, the tower skin was detected as a potential source of glare (see circular red marks in 4), particularly with low sun angle at 3 pm.

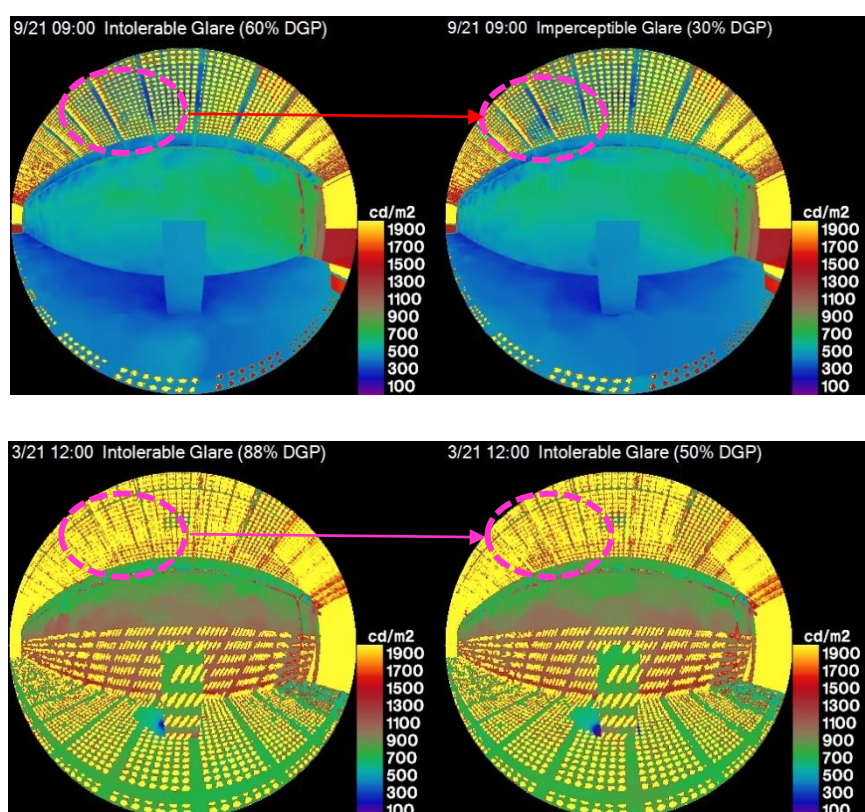
Figure 6 luminance maps generated from the perspective of visitor 1 with the current materials (left) and less reflective glazing assigned on the tower's skin (right)

The examples in Figure 6 show lower luminance levels detected on the tower when using less-reflective material compared to the current high reflective glazing (see magenta marks). Nevertheless, the reduction in DGP values resulted only in very few cases and didn't prevent glare. This essentially means that replacing the tower's skin, using less reflective material, may not solve the Museum Tower's negative impacts experienced inside the museum.

In fact, these results speculate that glare probability inside the museum increases, not only because of the material reflection, but it could be the elliptical geometry of the museum tower with multi surfaces that reflect the light. This brings some examples that have similar issues because of its convex outside geometry (e.g. Fenchurch tower in London). Even with low-reflective material, the estimated DGP was generally high. Additionally, in some cases, the analysis showed that not only the tower skin was detected as a potential source of glare, but also direct light from the sun and sky received from the ceiling through the shielding system contributed to glare occurrence (see Figure 5 6 left-bottom).
